# Dental Implants by Haytham Abbas

## BROKEN UPPER RIGHT 1ST MOLAR TOOTH

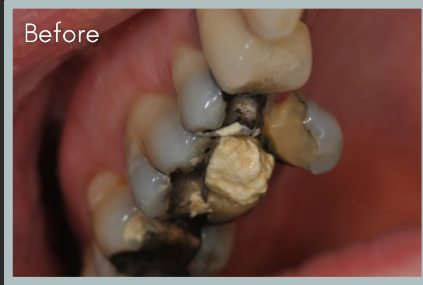
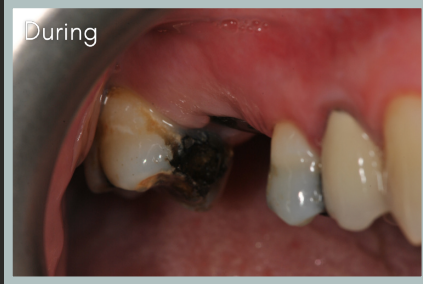
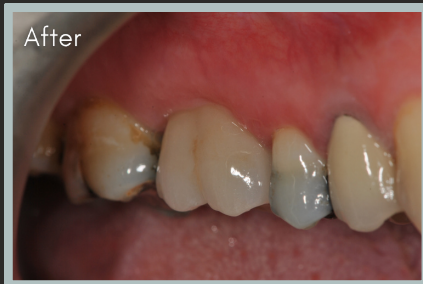
- Fractured and unrestorable upper right 1st molar
- All options discussed with patient opting for implant.
- Confirmed suitable for immediate implant treatment

- ✓ CT scan was taken to assess the bone volume and suitability for implant treatment.
- ✓ Tooth was extracted and an implant placed immediately along with a synthetic bone graft.
- ✓ Healing abutment placed along with two sutures, which were removed after two weeks of healing.
- ✓ Impressions for crown taken three months after implant placement.
- ✓ Crown fitted two weeks after impressions.
